Lake Mulwala

Water Quality Study

Vegetation Assessment

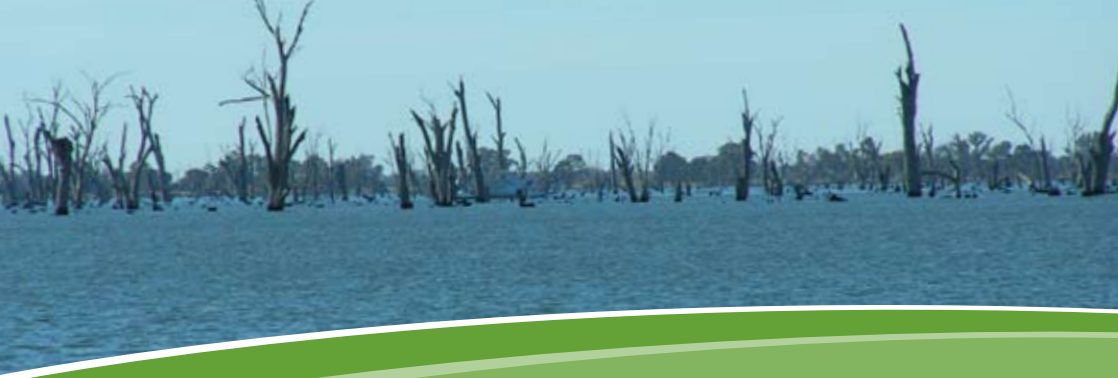
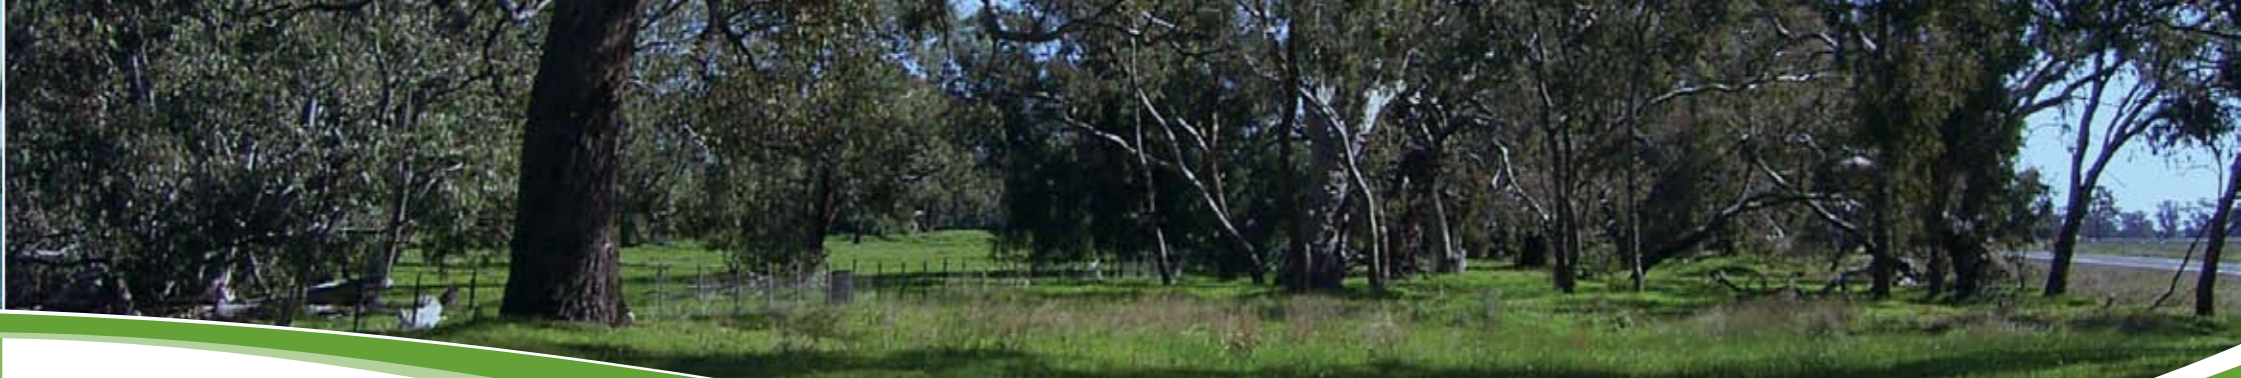
The spread of invasive Crack Willow trees is a potential threat to the health of the lake.

- The spread of invasive Crack Willow trees, Dense Waterweed and Arrowhead are potential threats to the lake's health. These species out-compete native vegetation and provide limited habitat for native species.
