Fact Sheet

Case study 1: Channel Automation Reduces Shepparton Irrigation Area Outfalls

Case study 2 – Automation reduces outfalls from CG9 and CG 19/6

Case study 3: Automation & channel lining – CG 2/2

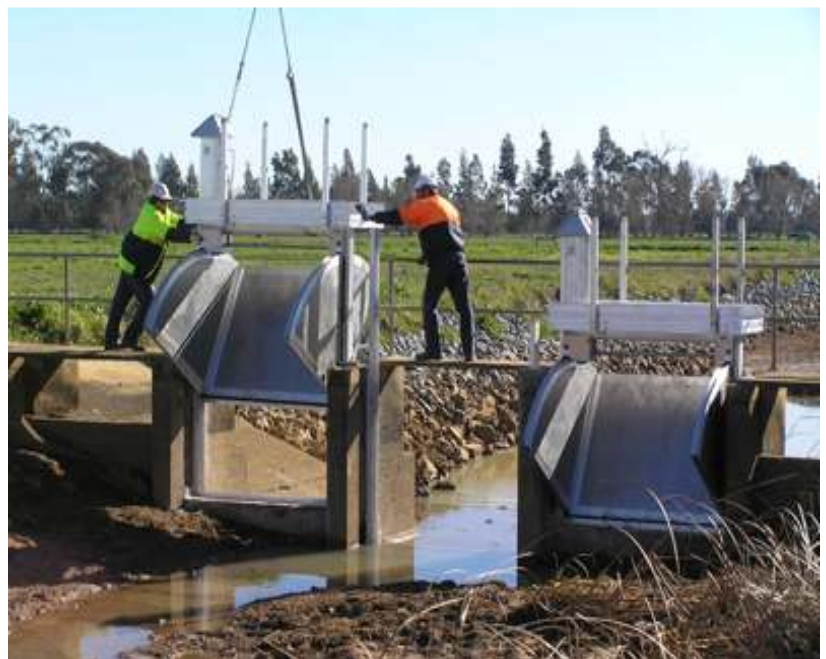
Installing automated regulators in the Shepparton Irrigation Area

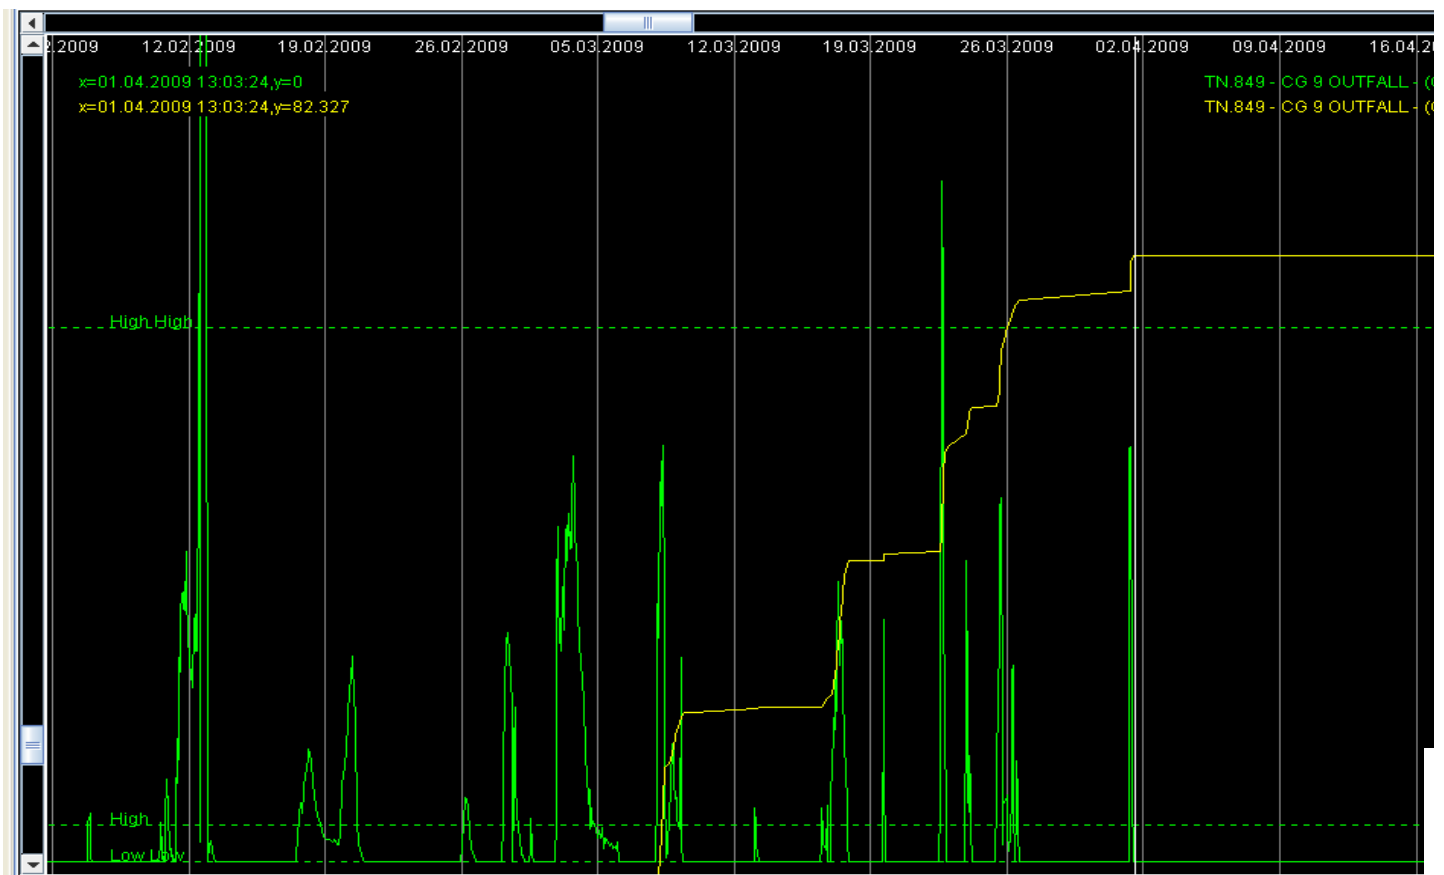
Example 1 – CG9 (green shows daily outfalls, yellow shows cumulative for season)

The screen image from G-MW channel automation system illustrates the dramatic impact of automation on system outfalls - since automation was 'turned on' on 2 April 2009 there has been no further measured increase to the 82ML of outfall recorded for the 2008/09 season.

The graphs from G-MW's operations database show that since channel automation was 'turned on' in March and April 2009, daily outfalls reduced by so much they are no longer measurable and as a result there was no further increase in outfalls for the entire season from the CG9 and CG 19/6.

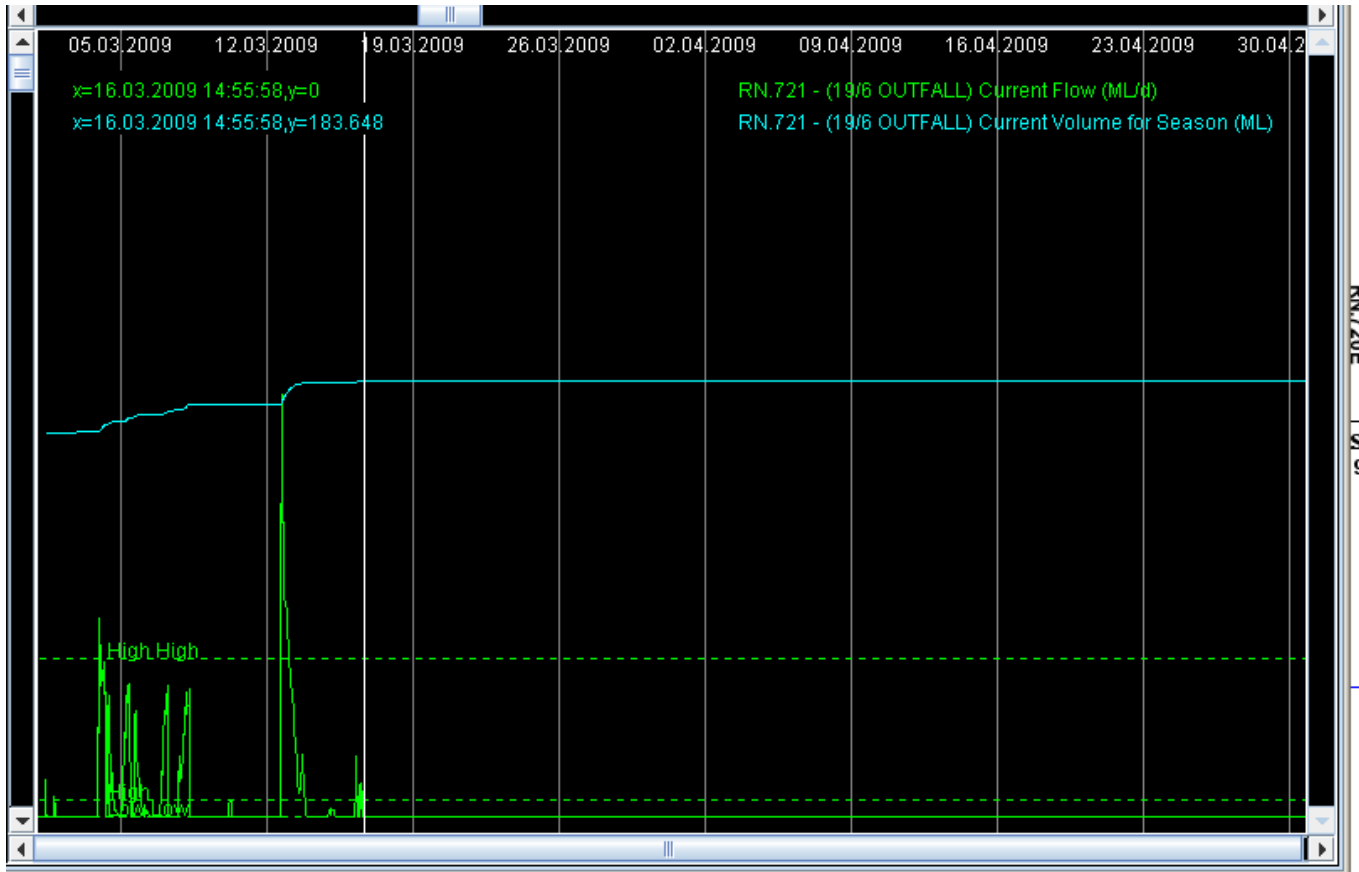
Example 2 – CG 19/6 (green shows daily outfalls, blue shows cumulative for season)

As this graph illustrates, from the day the channel regulators began operating, there has been no additional measured increase to the total volume of outfalls from the 19/6 for the 2008/09 season. G-MW recorded 183 ML of outfalls from start of the season up to 16 March 2009 when automation took over operations of the channel. There was no further measurable increase in outfalls from 16 March through to the end of the season.

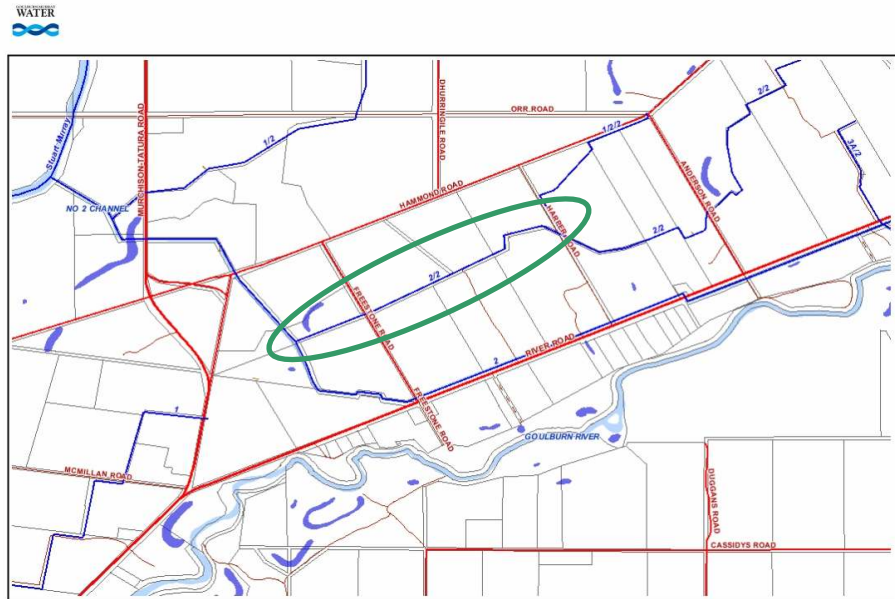
Location of CG2/2 channel lining Scale = 1:21,944 Composed by: lindsay Date: 12/08/2009

Automated regulators were installed along the channel in 2002/03 and 4.5km of the CG 2/2 channel was lined with HDPE plastic in 2008 as part of a larger lining project on the CG 2 system. The entire length of CG2/2 channel has been reshaped and lined with High Density Poly Ethylene (HDPE) black plastic, 2mm thick.

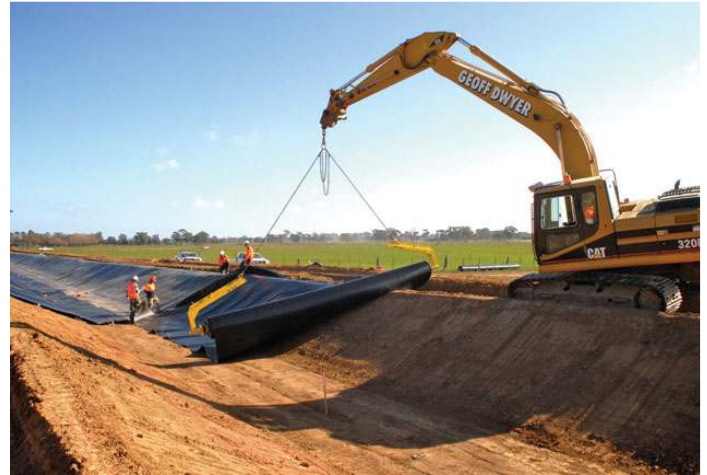
Installing HDPE channel lining during 2008 Winter works program

As part of the 2008 NVIRP Winter works program, a 5 km section of the CG9 open earthen channel was lined with High density poly ethylene (HDPE). Automated regulators were also installed at all sites along this section of channel.

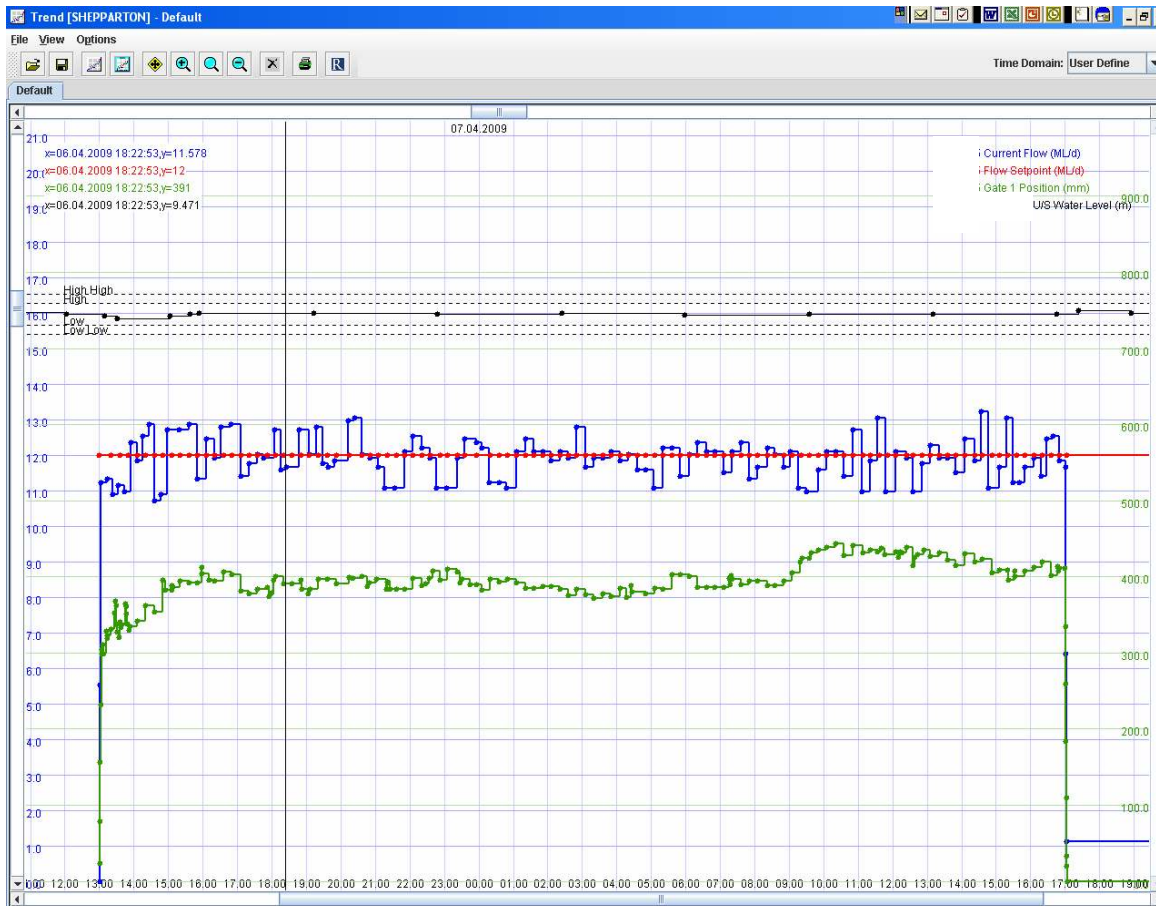
The following diagram shows the channel levels (black line) as well as the actual flow through the meter (blue line) tracked against the flow rate requested by the farmer (red line). The green line shows the movement of the outlet door to continuously adjust for any G-MW channel flow or level variations.

The graph demonstrates how flow rates and service levels onto farm can be maintained consistently and monitored through the use of smart meter outlets and channel automation.

Electronic Magflow and Flume gate meters talk continuously to their local channel regulators and the main database in Tatura to ensure flow rates through the meter are maintained at the level requested by the customer for the entire irrigation. The following graph shows the continuous monitoring of an irrigation delivery by a local farmer.
