CAMPASPE RIVER

ENVIRONMENTAL WATERING PLAN

ASSESSMENT AREA: CAMPASPE RIVER, CAMPASPE WEIR TO MURRAY RIVER

PREPARED FOR THE
NORTHERN VICTORIA IRRIGATION RENEWAL PROJECT

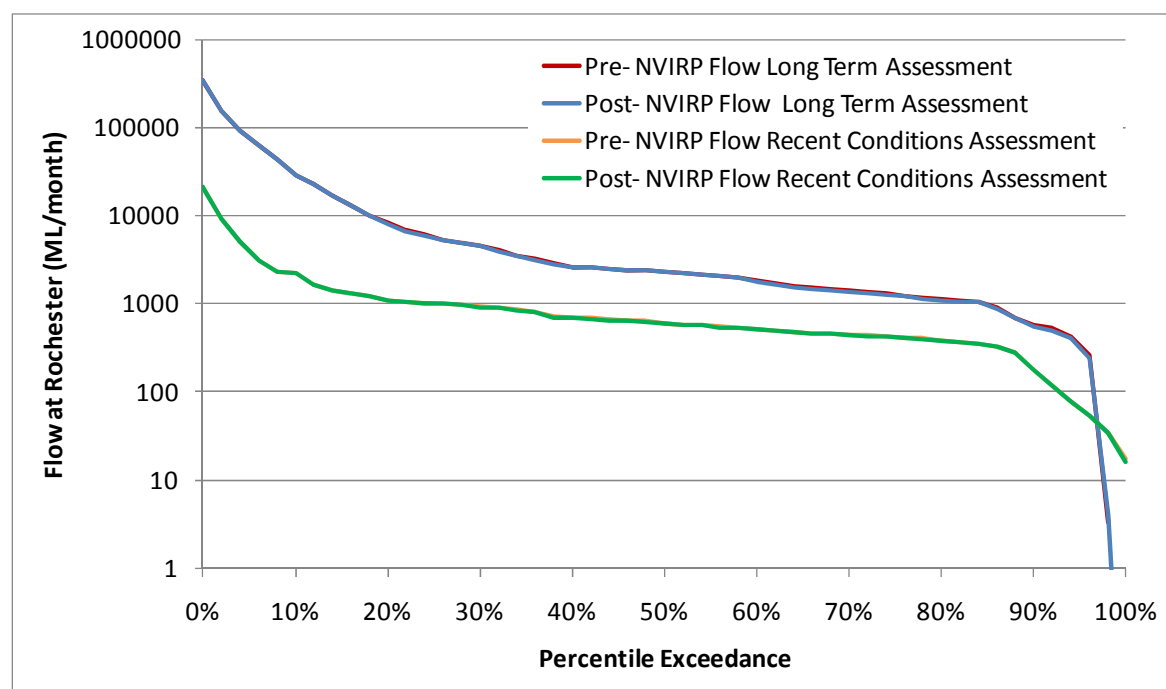
Figure 6: Flow duration curve of pre- and post-NVIRP streamflow for irrigation season months (August to April) at Rochester (Reach 3)

* - the percent reduction in flow for each key percentile is based on the average reduction in flow for percentiles $\pm 5\%$ of the specified percentile. This is to avoid results being skewed by a single, non-representative change. For example, the change reported for 90th percentile flows is based on the change for flows between the 85th and 95th percentiles.

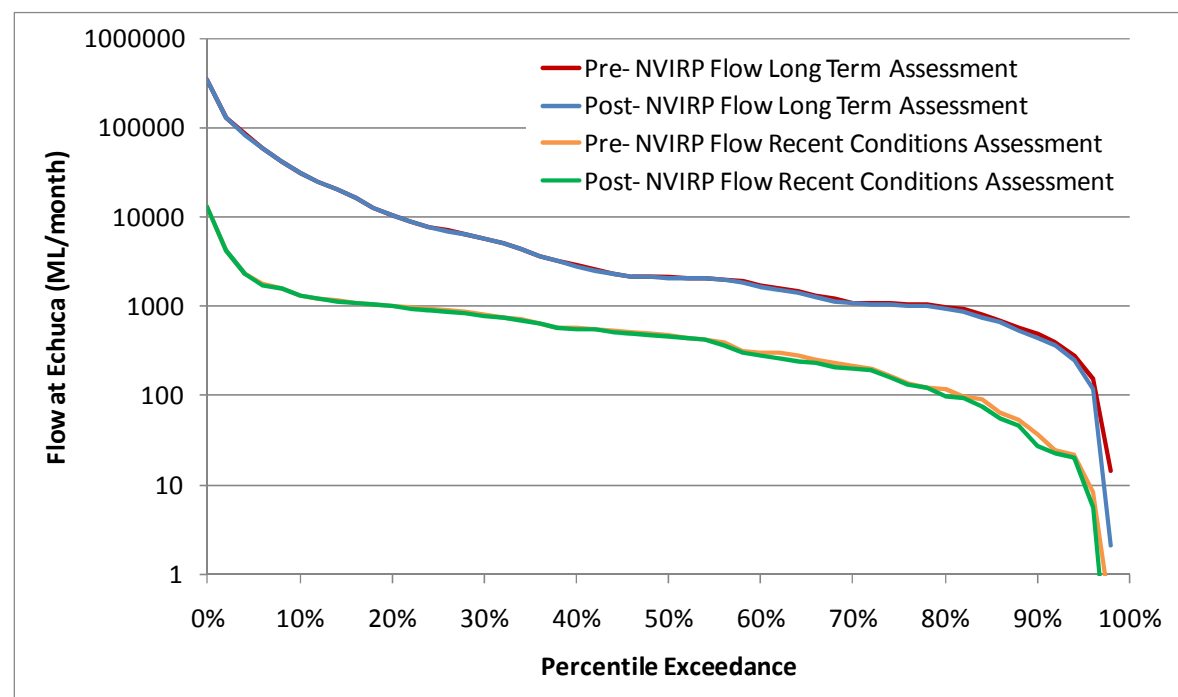
Figure 9: Flow duration curve of pre- and post-NVIRP streamflow for irrigation season months (August to April) at Echuca (Reach 4).

*- the percent reduction in flow for each key percentile is based on the average reduction in flow for percentiles $\pm 5\%$ of the specified percentile. This is to avoid results being skewed by a single, non-representative change. For example, the change reported for 90th percentile flows is based on the change for flows between the 85th and 95th percentiles.

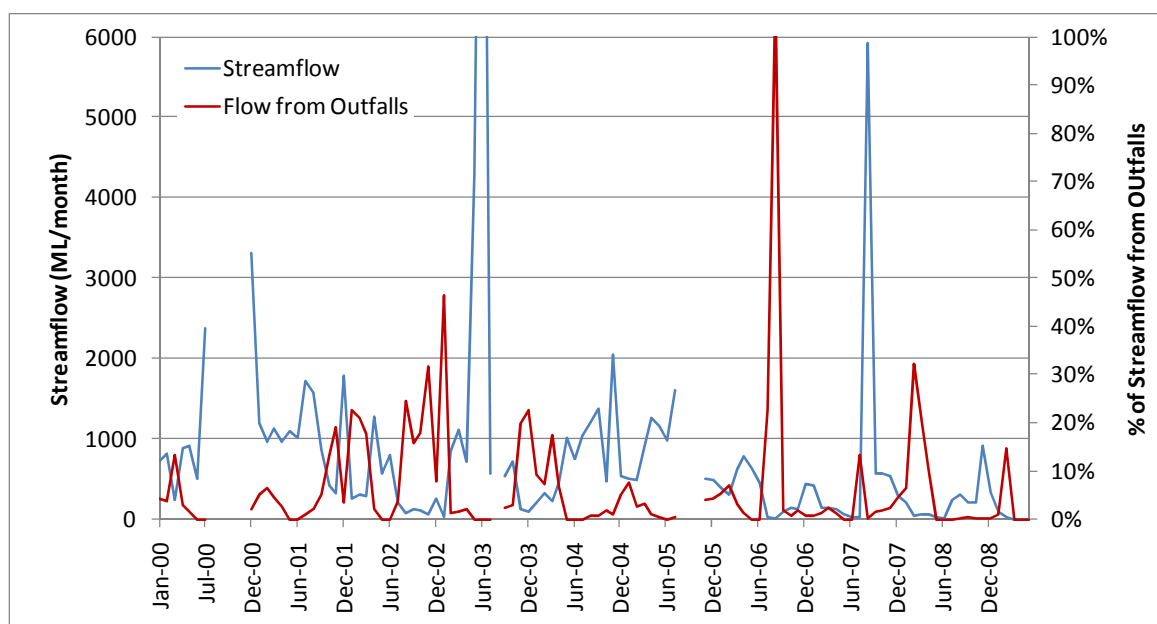
Figure 11: Time series plots showing the proportion of streamflow from outfalls for Echuca

Figure 11 highlights the contribution of channel outfall to the streamflow at Echuca.

From the above analysis the reduction in Campaspe River Reach 4 outfalls due to NVIRP is expected to lead to a small reduction in irrigation season flow at Echuca.

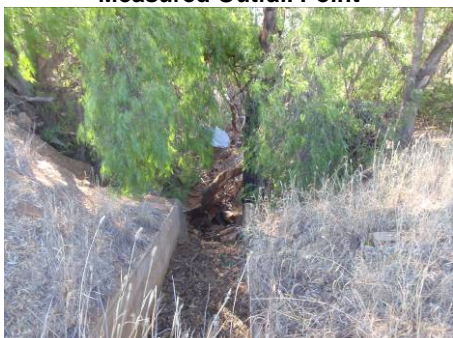
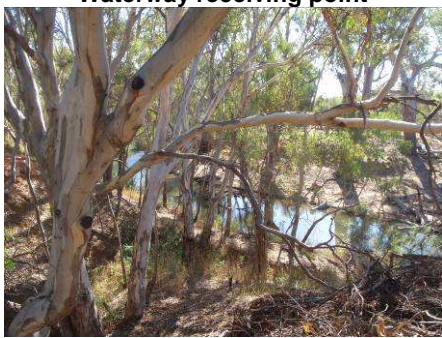
CAMPASPE IRRIGATION AREA - 2 nd March 2010			WGS1984 Zone55		
Receiving Waterway : Campaspe River			Irrigation Outfall : No 2 Accocks (ST032783)		
Easting		0293176	Northing		5969391
Measured Outfall Point			Waterway receiving point

Description		Off the Campaspe No. 2 main channel to a drain, then to the river (less than 1 km of drain). The drain is filled with rubbish (car parts, fences and old water tanks).			
Waterway Characteristics at outfall site			Refuge Rating (Key Water dependent values):		
Depth	~1-2m		Undercut banks	Yes	
Width	30m		Large woody debris	Moderate	
Velocity	<0.05m/s		Aquatic vegetation	Cumbungi, Phragmites and Spiny Rush	
Riparian Zone	Continuous RRGs and perennial grasses		Rating	Very Good	
Stock access	No, Crown Reserve		2003-04 Outfall Volume	98 ML	
Receiving Waterway : Campaspe River			Irrigation Outfall : No 1 (ST032729)		
Easting		0294319	Northing		5971326
Measured Outfall Point			Waterway receiving point

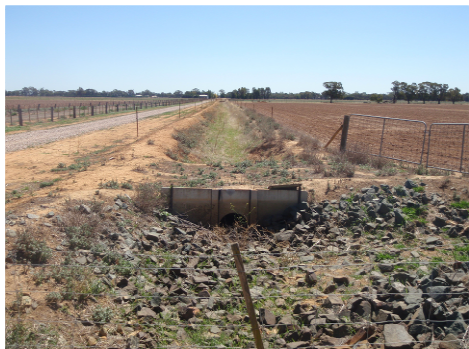
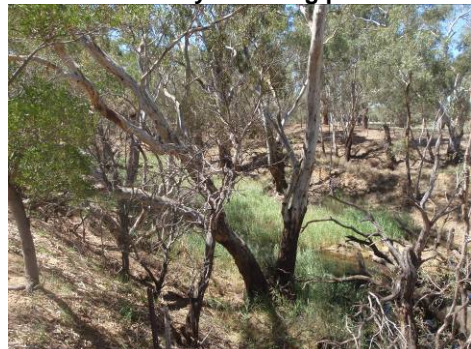
Description		Just south of Rochester. Off the bottom of the No. 1/1 channel to drain 7 then to the river (~1.5 km of drain)			
Waterway Characteristics at outfall site			Refuge Rating (Key Water dependent values):		
Depth	~1-2m		Undercut banks	Yes	
Width	30m		Large woody debris	Moderate	
Velocity	<0.05m/s		Aquatic vegetation	Cumbungi, Phragmites	
Riparian Zone	Continuous RRGs and perennial grasses		Rating	Very Good	
Stock access	No evidence		2003-04 Outfall Volume	0 ML

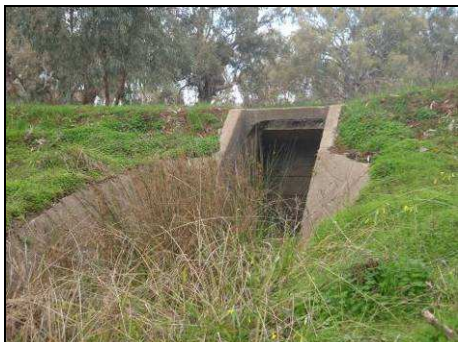
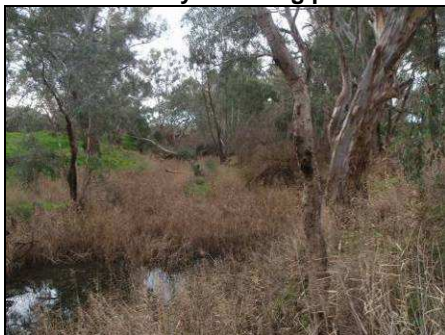
ROCHESTER IRRIGATION AREA – 28 th October 2009		WGS1984 Zone55	
Receiving Waterway : Campaspe River		Irrigation Outfall : No 12 (ST051358)	
Easting	0292683	Northing	5979065
Measured Outfall Point

Description	The No. 12 channel is located approximately four kilometres downstream of the Campaspe Siphon on the outskirts of Rochester. The outfall directly enters the Campaspe River (McColl Road)		
Waterway Characteristics at outfall site		Refuge Rating (Key Water dependent values):	
Depth	<4m	Undercut banks	Present
Width	<20m	Large woody debris	Moderate
Velocity	<0.5m/s	Aquatic vegetation	Phragmites
Riparian Zone	~5m RRG and grasses	Rating	Good
Stock access	No	2004-05 Outfall Volume	0 ML
Receiving Waterway : Campaspe River (Billabong)		Irrigation Outfall : No 1/14 (ST065860)	
Easting	0295888	Northing	5988672
Measured Outfall Point

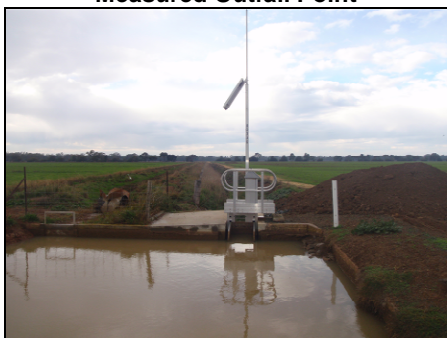
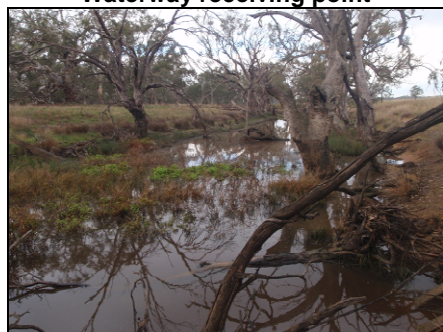
Description	The No. 1/14 channel outfall is located at the intersection of the Northern Highway and Winfield Road approximately 13 km south of Echuca and outfalls to a billabong of the Campaspe River. The No. 1/14 outfall is approximately 11 km upstream of where the billabong re-enters the Campaspe River. This section of the anabranch is also used as a reuse/recycle system by the adjacent landholder. Outfall from the No. 1/14 to a Billabong on the Campaspe anabranch. ~1.5 km of drain, then ~ 7 or 8km of anabranch (does not flow under normal conditions)

Waterway Characteristics at outfall site		Refuge Rating (Key Water dependent values):	
Depth	<1m	Undercut banks	Present
Width	<15m	Large woody debris	Moderate
Velocity	No flow	Aquatic vegetation	Extensive aquatic vegetation around the outfall pipe, Typha, abundant weeds (mostly annuals)
Riparian Zone	Sparse RRG and understory grasses	Rating	Moderate
Stock access	Yes	2004-05 Outfall Volume	204 ML

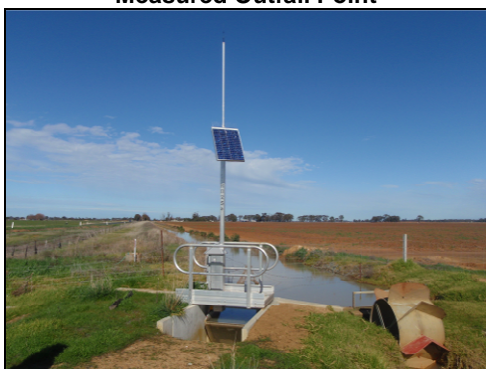
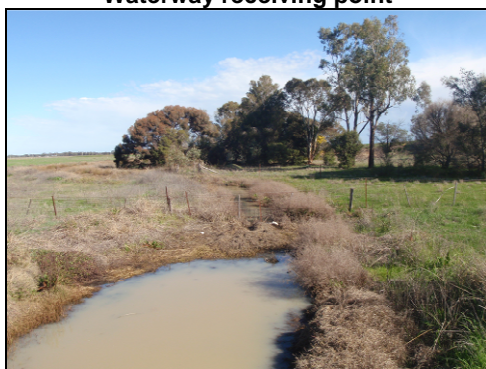
Receiving Waterway : Campaspe River (Unnamed Creek)		Irrigation Outfall : No 2/11 (ST033111)	
Easting	0300175	Northing	5990801
Measured Outfall Point

Description	The No. 2/11 channel outfall is located on the Echuca-Nanneela Road and outfalls into Rochester Drain 4 which flows for 2.9 km before entering an unnamed creek (currently dry). The creek meanders for a further 2.6 km before entering the Campaspe River. The total distance between the 2/11 outfall and the Campaspe River is approximately 5.5 km.		
Waterway Characteristics at outfall site		Refuge Rating (Key Water dependent values):	
Depth	<1m	Undercut banks	Absent
Width	<15m	Large woody debris	Minor
Velocity	No flow (creek dry)	Aquatic vegetation	The base of the creekline has patches of senescing <i>Typha</i> beds
Riparian Zone	Lignum and young RRG	Rating	Poor
Stock access	Yes (and residential)	2004-05 Outfall Volume	91 ML

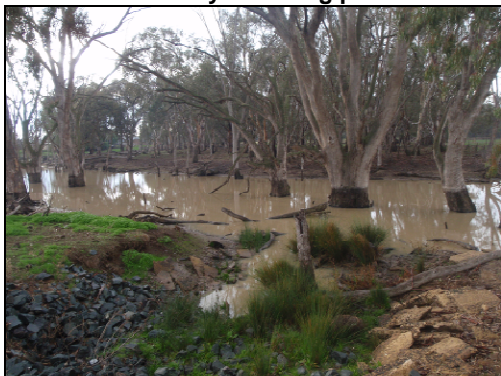
Receiving Waterway : Campaspe River (Billabong)		Irrigation Outfall : No 1/3/14 (ST033384)	
Easting	0296202	Northing	5994414
Measured Outfall Point

Description	The No. 1/3/14 channel outfall is located south of Matheson Road near Echuca and outfalls to an anabranch (Cahir's Billabong) of the Campaspe River. The No. 1/3/14 outfall is approximately 0.7 km upstream of where the anabranch re-enters the Campaspe River. This section of the anabranch is also used as a reuse/recycle system by the adjacent landholder who also holds an 89 ML/yr drainage diversion licence to extract water from the anabranch. Outfall from the No. 1/2/14 channel to the billabong on the Campaspe anabranch (via a short drain ~ 100 m)		
Waterway Characteristics at outfall site		Refuge Rating (Key Water dependent values):	
Depth	<1m	Undercut banks	Absent
Width	<15m	Large woody debris	There are a lot of dead stags in the permanently inundated zone that have drowned.

Velocity	No flow	Aquatic vegetation	No aquatic vegetation in the inundated zone
Riparian Zone	Lignum and young RRG	Rating	Poor
Stock access	Yes (and residential)	2004-05 Outfall Volume	13 ML

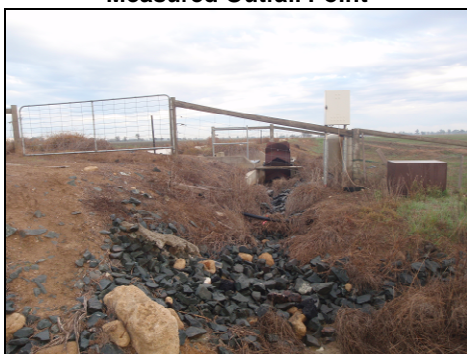
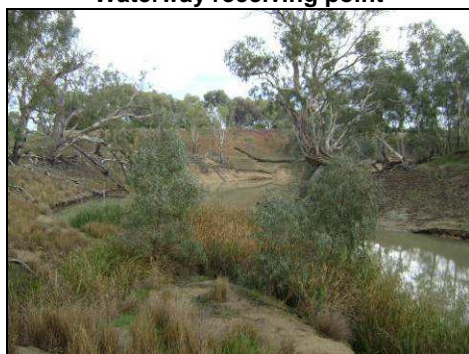
Receiving Waterway : Campaspe River		Irrigation Outfall : No 2/1/3/4 (ST033397)	
Easting	0295986	Northing	5996057
Measured Outfall Point		Waterway receiving point

Description	The No. 2/1/3/14 channel outfall is located adjacent to the Northern Highway on the outskirts of Echuca and outfalls to Rochester Drain 1A/2 (measurement site) which in turn outfalls to Rochester Drain 2 at the Northern Highway before it outfalls into the Campaspe River (a total length of approx 1.5 km). Outfall from the No. 2/1/3/14 channel to a short drain and then a short creek (~ 0.5 km) before flowing into the Campaspe		
Waterway Characteristics at outfall site		Refuge Rating (Key Water dependent values):	
Depth	<4m	Undercut banks	Present
Width	<20m	Large woody debris	Moderate
Velocity	<0.5m/s	Aquatic vegetation	Phragmites and Typha
Riparian Zone	~5m RRG and grasses	Rating	Good
Stock access	No	2004-05 Outfall Volume	60 ML

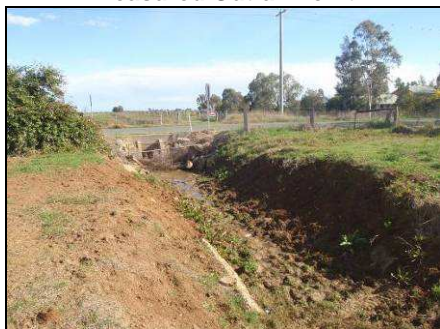
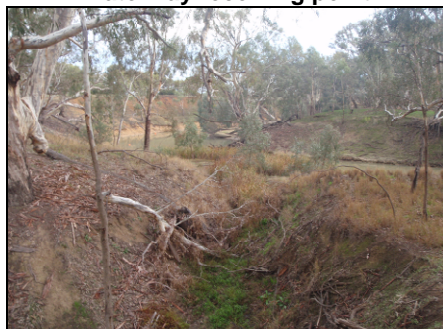
Receiving Waterway : Campaspe River		Irrigation Outfall : No 1/4/3/14 (ST033425)	
Easting	0293150	Northing	5995981
Measured Outfall Point		Waterway receiving point

Description	The No. 1/4/3/14 channel outfall is located near Crumpler Road on the outskirts of Echuca. It outfalls into Rochester Drain 2 which flows for approximately 3 km before it enters the Campaspe River (the same site as channel outfall 2/1/3/14 – Refer to Section 6 in the Campaspe River Interim EWP). Figure A5 below illustrates the outfall site and its proximity to the Campaspe River. According to G-MW there are currently no licensed drainage diversers downstream of the No. 1/4/1/14 channel outfall.		
Waterway Characteristics at outfall site		Refuge Rating (Key Water dependent values):	
Depth	<4m	Undercut banks	Present
Width	<20m	Large woody debris	Moderate
Velocity	<0.5m/s	Aquatic vegetation	Phragmites
Riparian Zone	~5m RRG and grasses	Rating	Good

Stock access	No	2004-05 Outfall Volume	62 ML

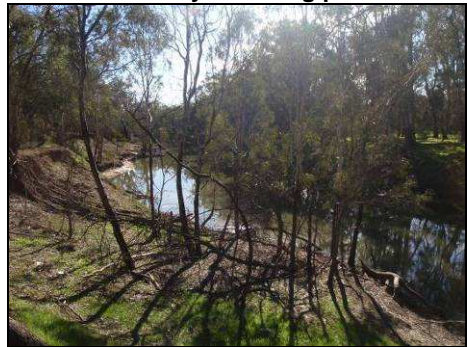
Description	The No. 5/3/14 channel outfall is located on the Mount Terrick Road on the outskirts of Echuca. It outfalls into Rochester Drain 1 which flows for approximately 1.2 km to Wharparilla Reserve and then flows for a further 1.9 km before it enters the Campaspe River (a total distance of approximately 3.1 km).		
Waterway Characteristics at outfall site		Refuge Rating (Key Water dependent values):	
Depth	<4m	Undercut banks	Present
Width	<20m	Large woody debris	Moderate
Velocity	<0.5m/s	Aquatic vegetation	Phragmites and Typha
Riparian Zone	~5m RRG and grasses	Rating	Good
Stock access	No	2004-05 Outfall Volume	213 ML
