Northern Victoria Irrigation Renewal Project

Waterway Short-Listing Report

Final Report

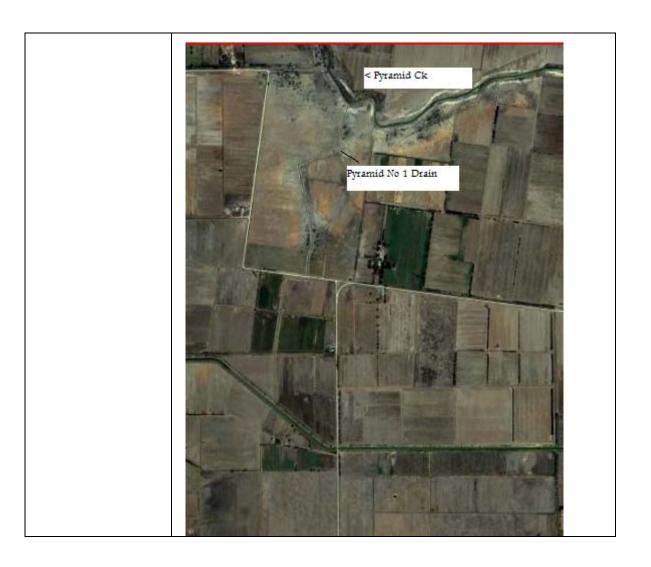
1	After taking into account the drainage diversion volume which could be diverted for use, it is considered likely that approximately 60 % of the total outfall volume could enter Pyramid Creek. However the distance travelled by the outfall water to Pyramid Creek indicates that further outfall water is may be lost due to seepage and evaporation before entering Pyramid Creek. There is likely to be some impact on flow as a result of reduced channel outfall.	
Recommendation i	Given the change of flow conditions in the Pyramid Creek due to a reduction in channel outfalls associated with the FBM Project further investigation into the environmental impact of the FBM Project on this waterway is recommended.	
Recommendation	lot at risk due to the low environmental values. It is recommended that no further investigation be undertaken	
Location Plan	From SKM maps of channel outfalls:
