# Goulburn-Murray Water

## In-situ Testing of Dethridge Meter Accuracy in the Goulburn-Murray Irrigation District

**September 2009**

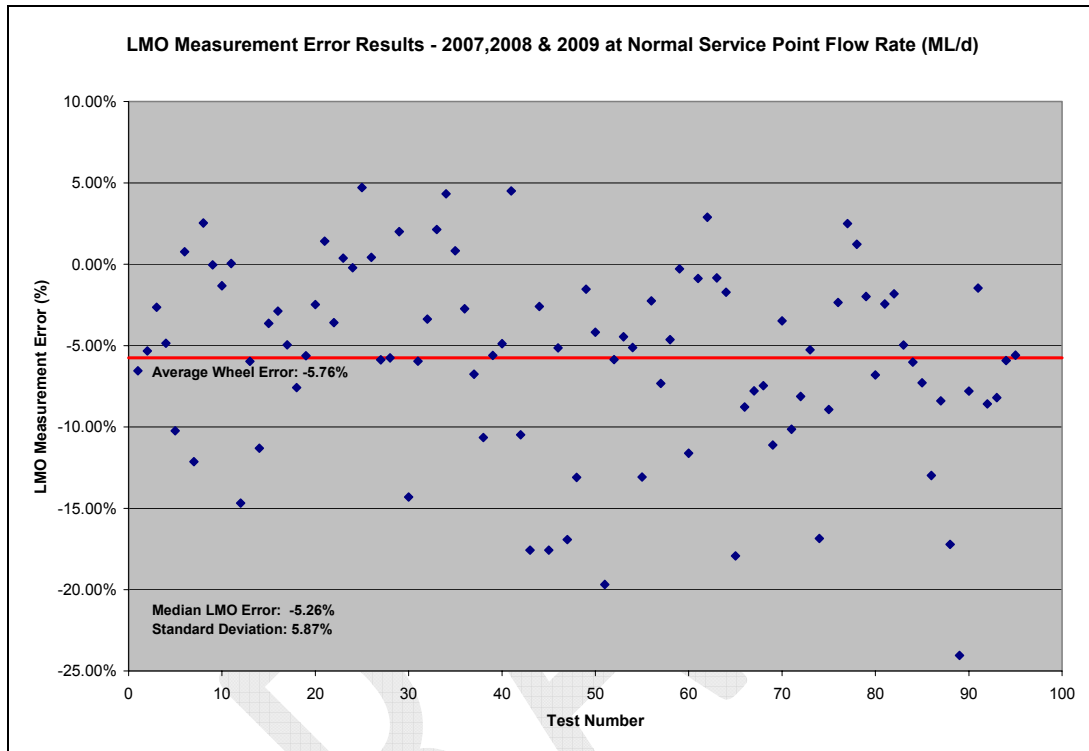
**Figure E1** provides a graphical representation of the spread of LMO measurement error at their normal operating flow across the GMID. This graph shows the large scatter of accuracy which ranges between -24.05% to 4.72% with a mean of -5.76%. Variables such as bottom clearance, tailwater depth, supply depth, maintenance issues and flow rate have been assessed against measurement error for the same sample of data and are discussed in detail in the report to help explain the high level of variability in the results.

**Figure E1: Spread of GMID LMO Measurement Error (%)**

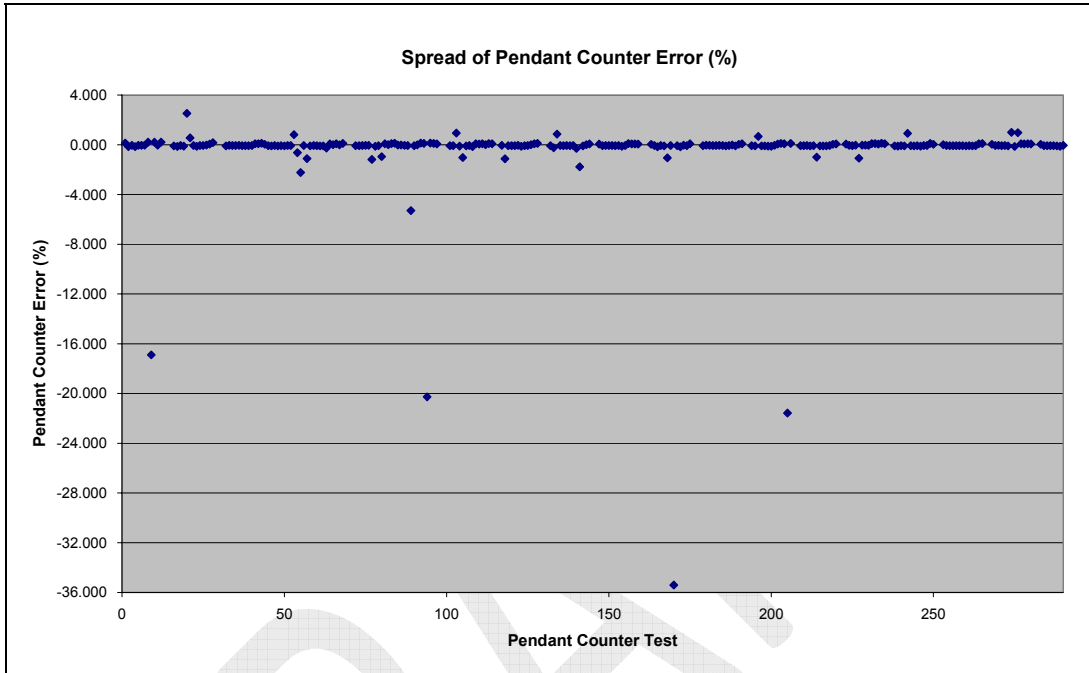
The results presented in **Figure 1** and **Figure 2** comprises the three Dethridge meter (LMO, DLMO and SMO) pendant counters that are used and operating in the GMID. **Figure 1** shows the spread of G-MW pendant counter accuracy excluding outliers that would have been identified as part of G-MW's field checking system. With the exception of a small sample of pendant counters, the sample of 281 pendant counters included in the analysis had an average measurement error of -0.45% and a standard deviation of 3.02%.

**Figure 1: Spread of G-MW Pendant Counter Accuracy.**

Based on the pendant counter testing undertaken by G-MW it can be concluded that on average G-MW pendant counters under record (in favour of the G-MW customer) by approximately -0.45% with a standard deviation of 3.02%. A small proportion (2.4%) of Dethridge meter pendant counters are prone to complete failure. However, as long as a field checking system is in place, the pendant counter, for use as a customer billing tool is considered robust and accurate.

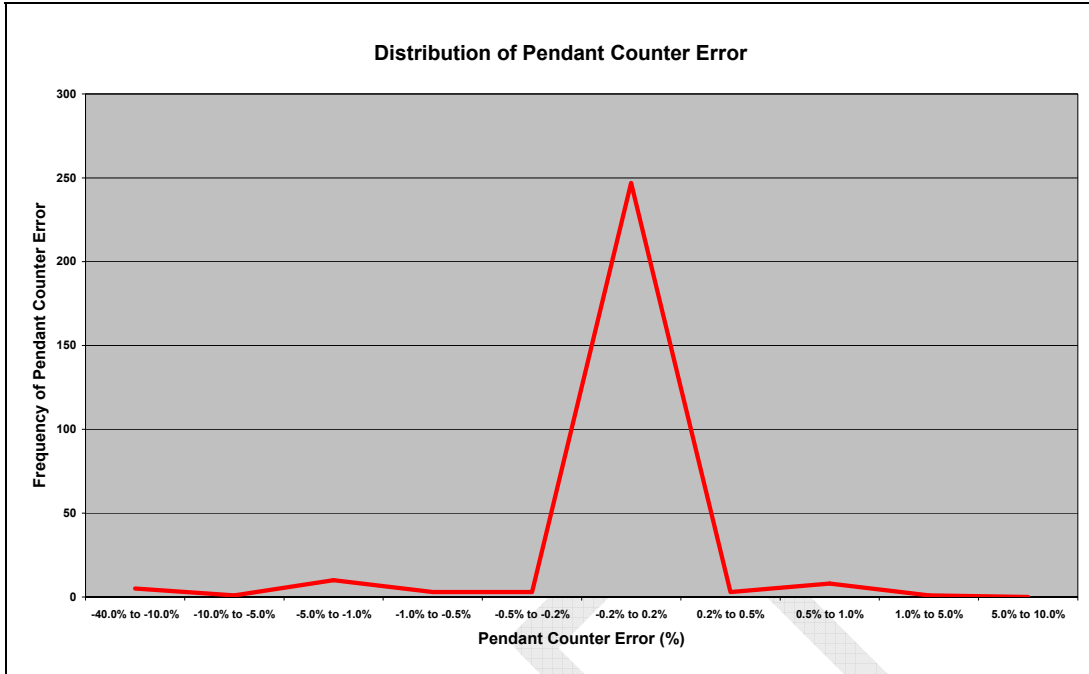
**Figure 2** shows the distribution of pendant counter error which provides a visual representation of where the vast majority of the results fall. Of the 281 pendant counters included in the analysis 247 measured between -0.20% and 0.20%, which is a total of 88% of all pendant counters tested.

**Figure 2: Distribution of G-MW Pendant Counter Accuracy.**

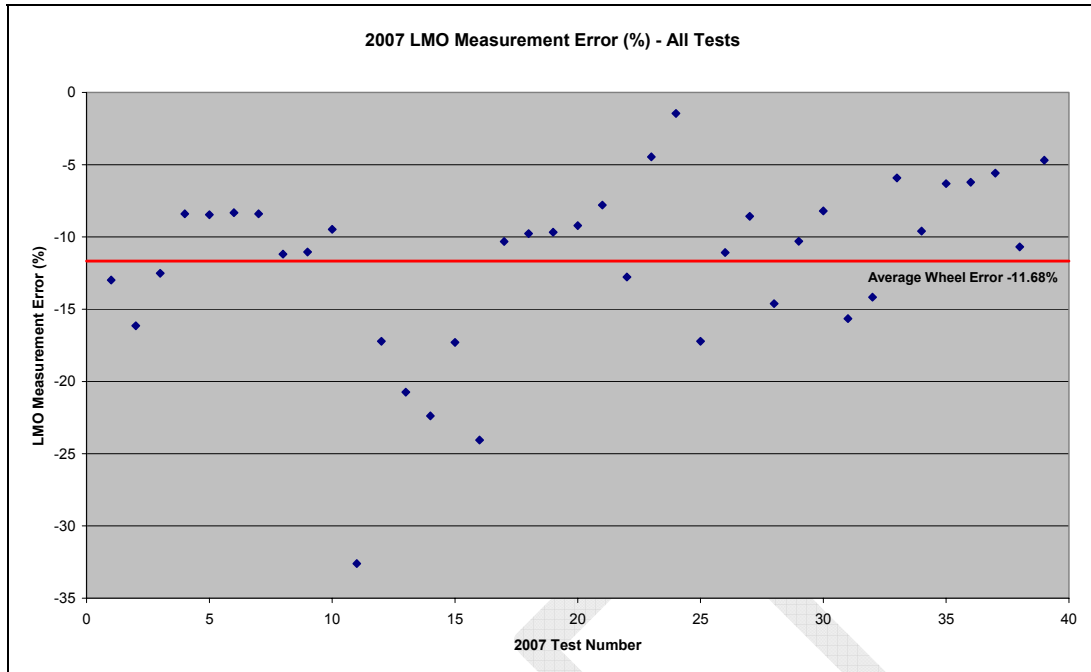
In-situ testing was undertaken by Thiess Services in the Central Goulburn Irrigation Area between 17 January and 6 February 2007 on 10 LMOs. The results analysed in this section include the high, normal and low flow data. **Figure 3** shows the spread of LMO measurement results from the 2007 testing.

Flow rates for the 10 LMOs tested in 2007 varied from 2.97 ML/d to 11.30 ML/d, with one of the 37 flow tests being below the minimum flow recommended for the LMO (at least 3ML/d). The results of the 2007 in-situ Dethridge meter testing are presented graphically in **Figure 3**.

**Figure 3: 2007 LMO Accuracy Results – All Tests.**

These results exclude two anomalous test results. These were also excluded in previous reporting (Hydro Environmental, 2008).<sup>6</sup>

**Figure 3** shows a large scatter within the results which highlights the highly variable nature of Dethridge meter accuracy that is influenced by many of the factors listed in **Section 2.6.2**.

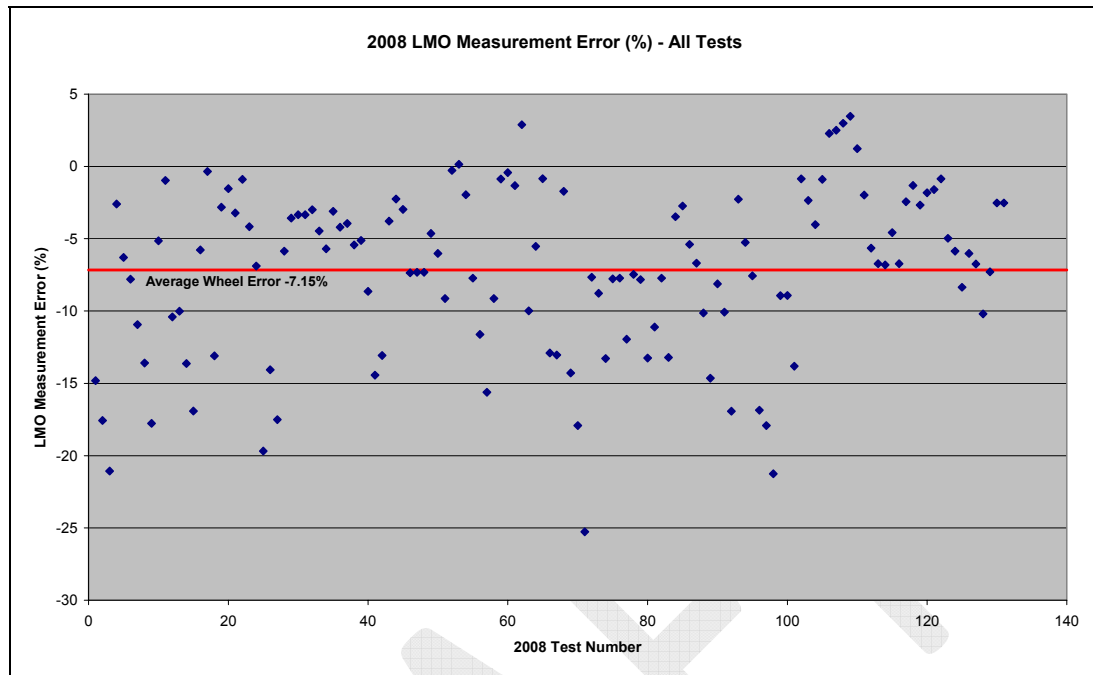
In-situ testing was undertaken by Thiess Services in the Central Goulburn, Rochester, Pyramid-Boort, Shepparton, Murray Valley and Torrumbarry Irrigation Areas between 27 September 2007 and 21 February 2008 on 43 LMOs. The results analysed in this section include the high, normal and low flow data for all service points tested. **Figure 4** shows the spread of LMO measurement results from the 2008 testing.

3 ML/d). The results of the 2008 in-situ Dethridge meter testing are presented graphically in **Figure 4**.

**Figure 4: 2008 LMO Accuracy Results – All Tests.**

**Figure 4** shows the LMO measurement error for a range of LMOs tested across the GMID in 2008. As was the case in the 2007 results, there is a large scatter within the results which highlights the inherent highly variable nature of Dethridge meter accuracy that is influenced by many of the factors listed in **Section 2.6.2**.

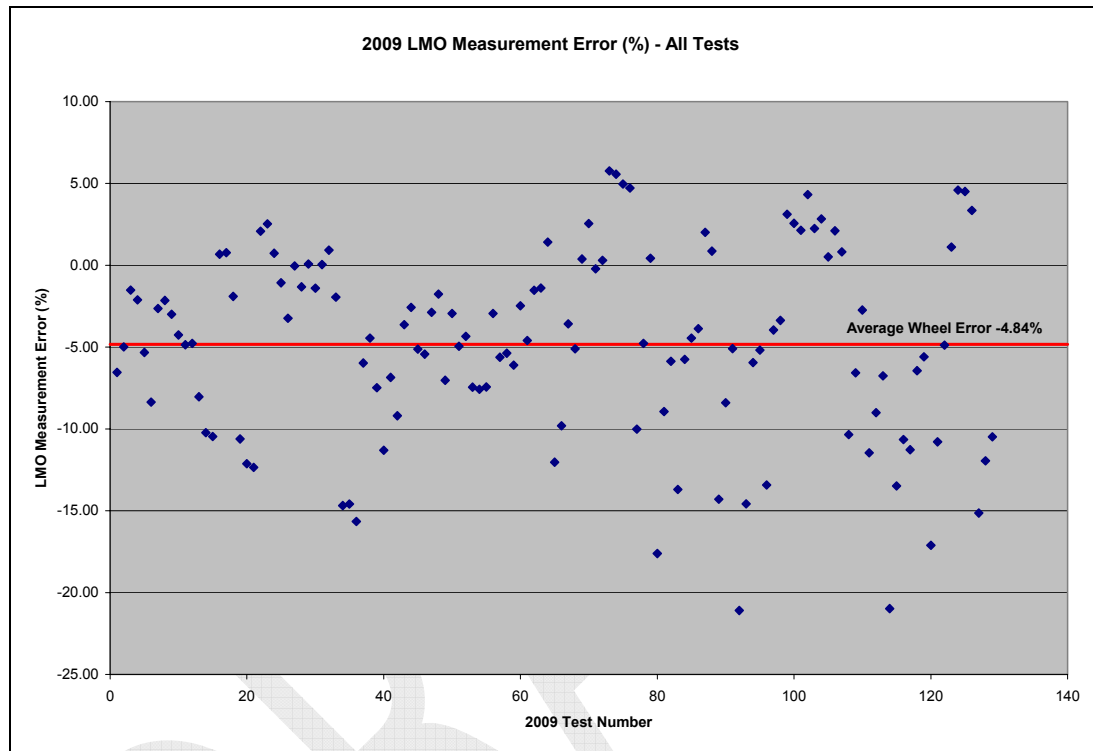
Control Solutions. The results analysed in this section include the high, normal and low flow data. **Figure 5** shows the spread of LMO measurement error results from the 2009 testing.

Flow rates for the 42 LMOs tested in 2009 varied from 2.79 ML/d to 14.36 ML/d, with ten of the 128 flow tests being below the minimum flow recommended for the LMO (at least 3 ML/d). The results of the 2009 in-situ Dethridge meter testing are presented graphically in **Figure 5**.

**Figure 5: 2009 LMO Accuracy Results – All Tests.**

**Figure 5** shows the LMO measurement error for a range of LMOs tested across the GMID in 2009. As was the case with the 2007 and 2008 testing there is a large scatter within the results which highlights the highly variable nature of Dethridge meter accuracy that is influenced by all of the factors listed in **Section 2.6.2**.

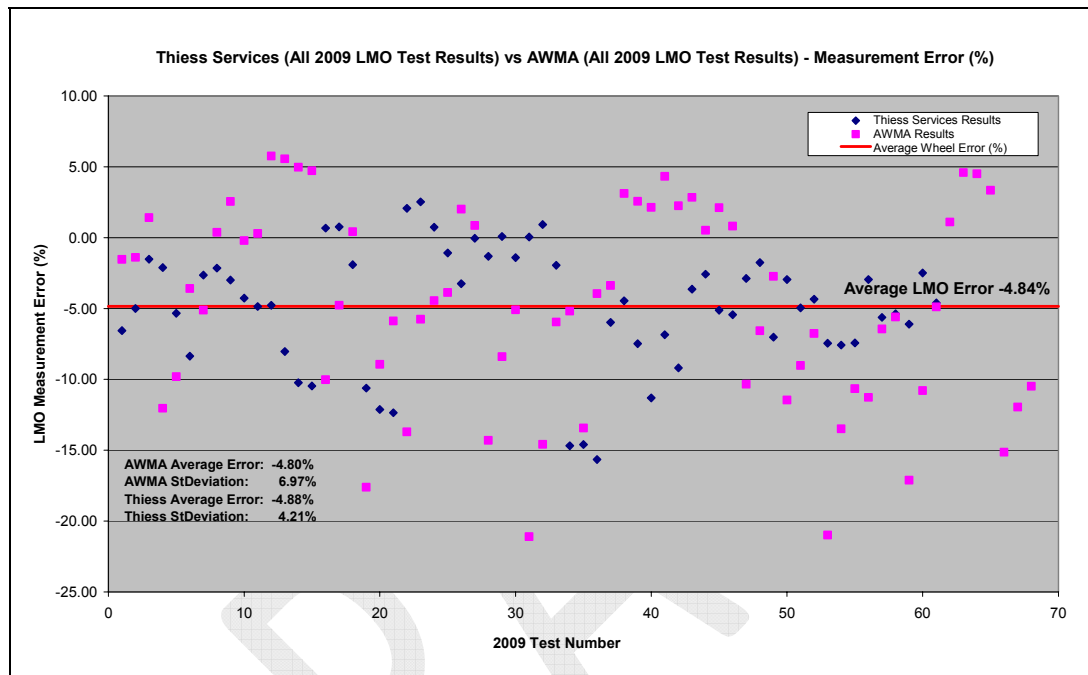
Although the IMVR designs are different, the setup and procedures of both contractors are fundamentally the same. The graph shown in **Figure 6** shows the spread of LMO measurement error as tested and calculated by both contractors for different service points in six different Irrigation Areas across the GMID. Ideally, some overlap of tested meters should have occurred, however no overlap was designed into the G-MW testing programme.

**Figure 6: Comparison of Contractor LMO Accuracy Results for 2009 Testing.**

The average measurement error for the tests undertaken by each contractor was nearly identical. The average measurement error as measured and calculated by AWMA Water Control Solutions was -4.80%, and the average measurement error as measured and calculated by Thiess Services was -4.88%.

The spread of results from each contractor is however markedly different; the Thiess Services results have a standard deviation of 4.21% whereas the AWMA Water Control Solutions spread of results have a standard deviation of 6.97%. Although the mean LMO error is very close for each contractor, the spread of results is most likely due to a number of variables associated with the characteristics of the Dethridge meters tested. These variables include fin bottom clearance, supply depth, tailwater depth, flow rate and the condition of the wheel and concrete emplacement. However, as no overlap of Irrigation Area, and hence no overlap of service point testing was achieved, a direct comparison of the relative test rig accuracy could not be made.

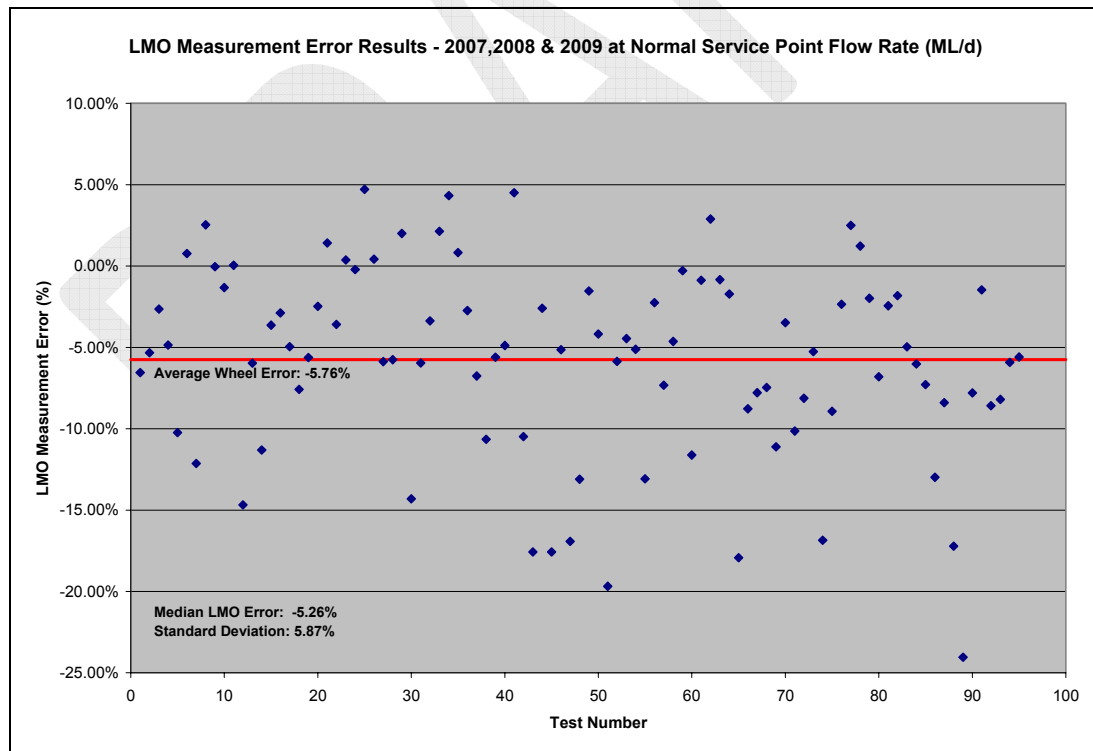
**Figure 7** shows the spread of LMO measurement error for all LMOs tested at their normal operating flow. The average LMO measurement error is -5.76% with a standard deviation of 5.87%.

Figure 7: GMID LMO measurement error (%) spread.

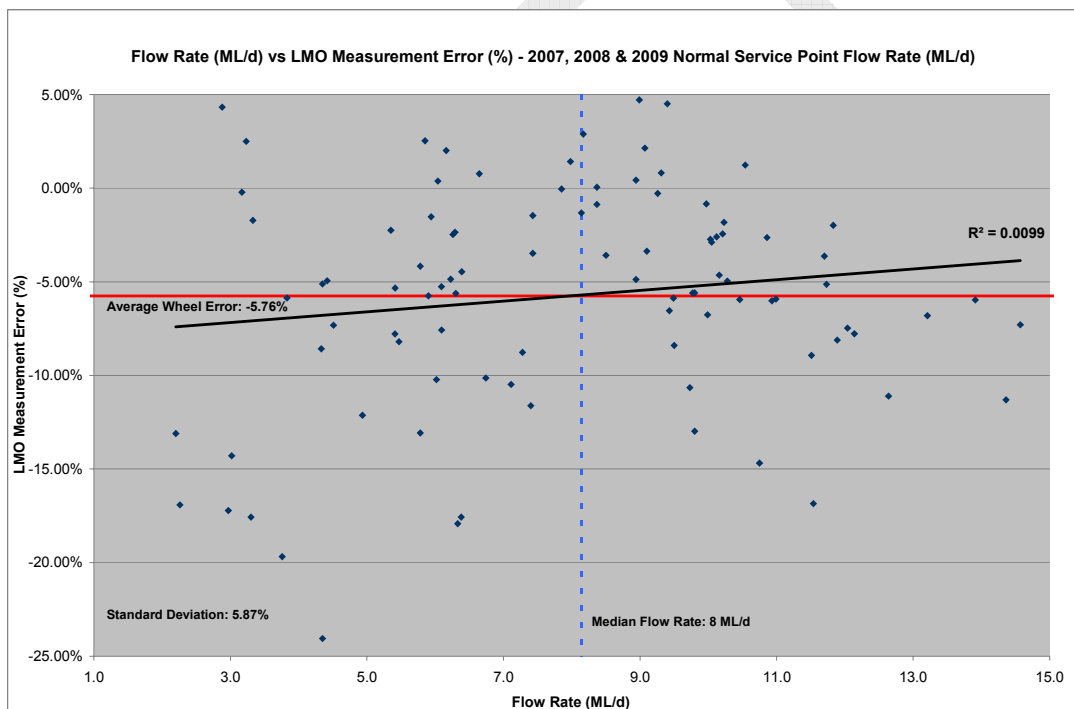
**Figure 8** shows the LMO measurement error for a range of flow rates across the six Irrigation Areas. The median flow rate tested was 8.14 ML/d. The high variability in the results show that a relationship between LMO measurement error (%) and flow rate (ML/d) is virtually non-existent with an R<sup>2</sup> value of less than 1%. (The R<sup>2</sup> value, or the coefficient of determination indicates the strength of fit between two variables by calculating the variation in one value that occurs in proportion to variations in another value. In this case, flow rate vs. measurement error, where less than 1% of the variability in the LMO measurement error can be explained by the different flow rates used for the in-situ tests).

However, overall these results indicate that on average LMO measurement error changes by + 0.3% for every ML change in flow.

**Figure 8: GMID LMO measurement error (%) vs. Flow Rate (ML/d).**

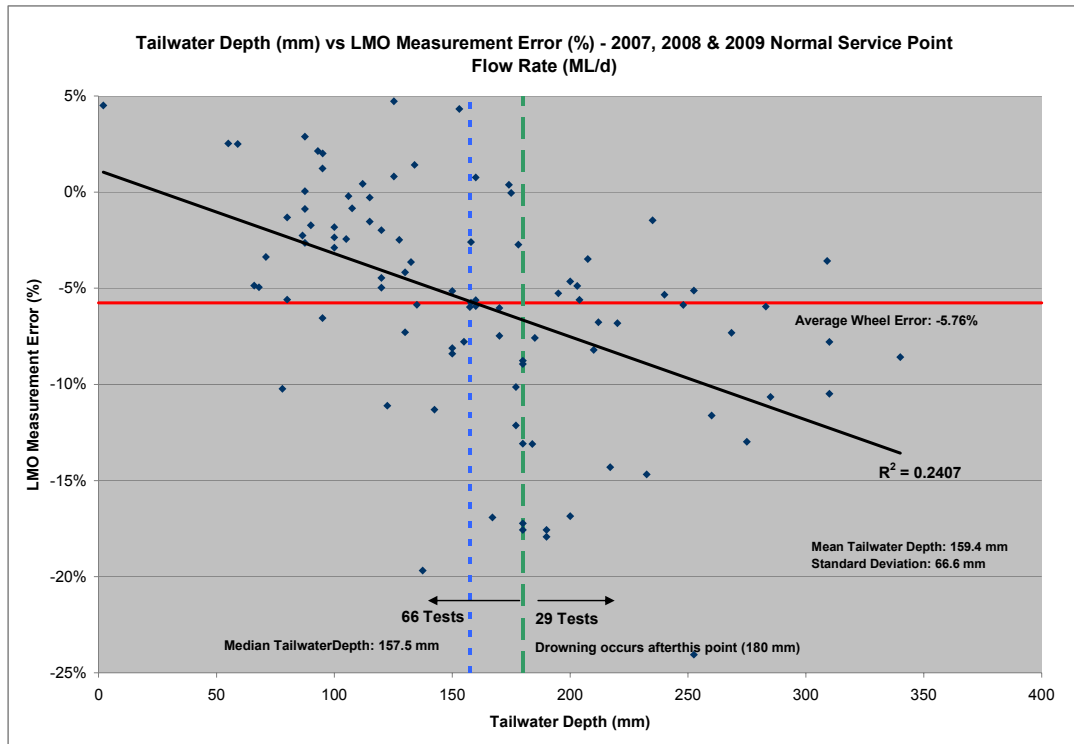
The range of tailwater depths in which testing was conducted for LMOs in the GMID is shown graphically in **Figure 9**. The average tailwater depth was 159 mm compared with the 180 mm allowed before the flow condition is considered drowned under a standard supply depth of 380 mm.. The high variability in the results shows that the relationship between LMO measurement error (%) and tailwater depth (mm) is very weak with an R<sup>2</sup> value of approximately 24%. Tests with a tailwater level below 180 mm recorded an average measurement error of -4.33%, whilst those tests with tailwater depths greater than 180 mm had an average measurement error of -9.26%.

Overall these results indicate that LMO measurement changes by -0.04% for each mm increase in tailwater depth.

Figure 9: GMID LMO measurement error (%) vs. Tailwater Depth (mm).

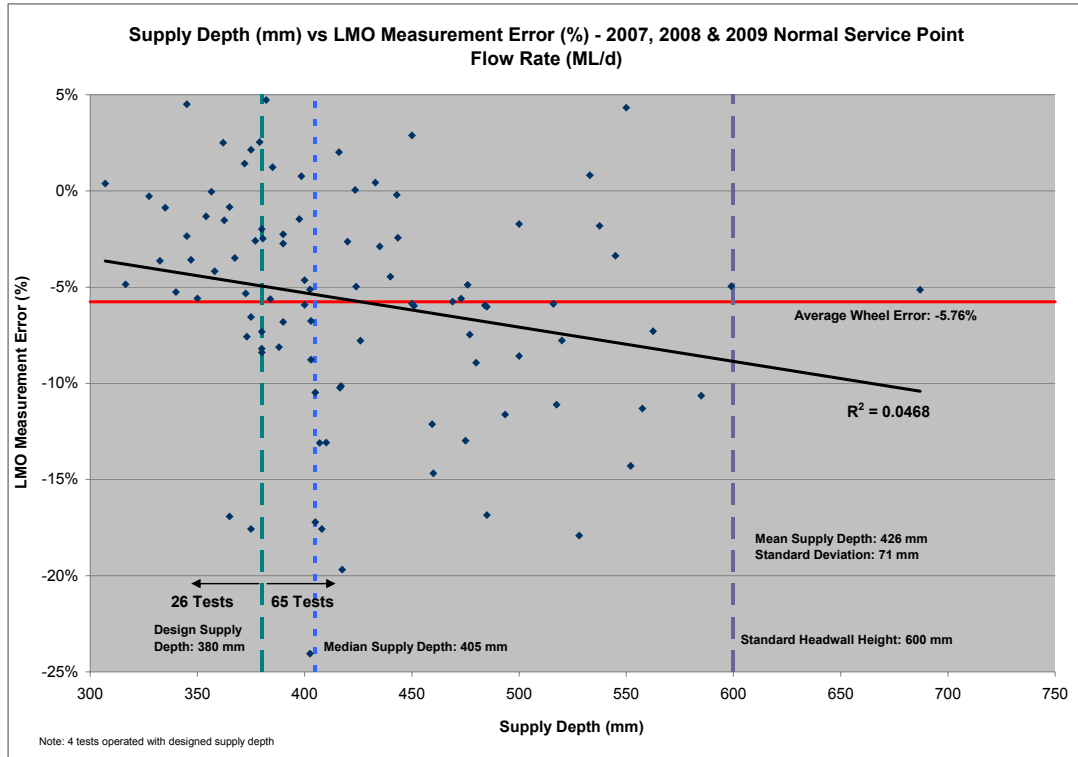
The range of supply depths in which testing was conducted for LMOs in the GMID is illustrated in **Figure 10**. The average supply depth for the series of tests was 426 mm compared to the design supply depth of 380 mm. The high variability in the results shows that a relationship between LMO measurement error (%) and supply depth (mm) is essentially absent with an  $R^2$  value of approximately 5%. Supply depths greater than the recommended supply depth can have a negative result on the accuracy of the LMO. This can result in a change in measurement error of -0.02% per mm rise in level. If supply depth is better controlled by automation this could lead to an improvement of 0.2% for each reduction of 10 mm in channel water level where LMOs are retained.

Results presented in **Figure 10** show those tests undertaken with a supply depth of greater than the standard 380 mm had an average measurement error of -6.85% whilst tests undertaken with a supply depth below 380 mm had an average measurement error of -3.52%.

Figure 10: GMID LMO measurement error (%) vs. Supply Depth (mm).

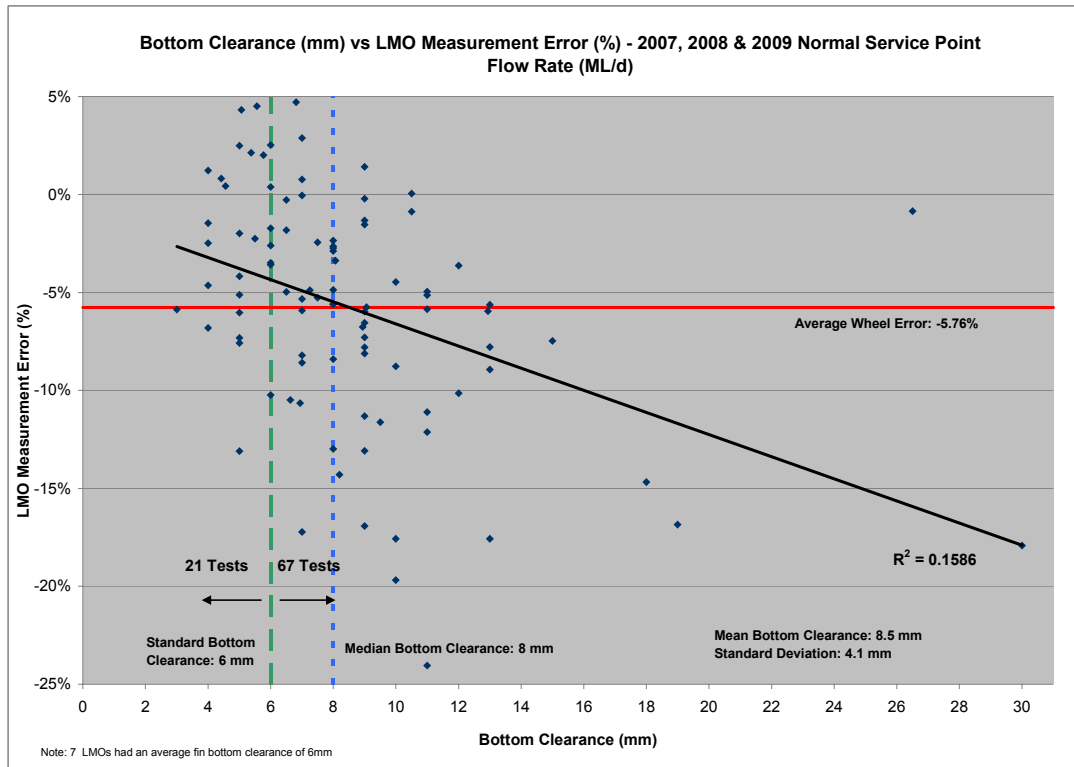
The standard bottom clearance for a G-MW LMO is 6 mm. The range of average fin bottom clearances for the 95 sites reported varied between 3.0 mm and 30.0 mm with an overall average of 8.5 mm, 2.5 mm above the standard design bottom clearance. The LMO accuracy results are graphed against average fin bottom clearance in **Figure 11**.

The high variability in the results shows a weak relationship between LMO measurement error (%) and bottom clearance (mm) with an R<sup>2</sup> value of approximately 16%. The results indicate that LMO measurement error changes by -0.56% for each mm change in bottom clearance. However, the tests with an average bottom clearance less than 6 mm had an average measurement error of -2.48%, in comparison; the tests undertaken with an average bottom clearance above 6 mm had an average measurement error of -7.09%.

Figure 11: GMID LMO measurement error (%) vs. Bottom Clearance (mm).

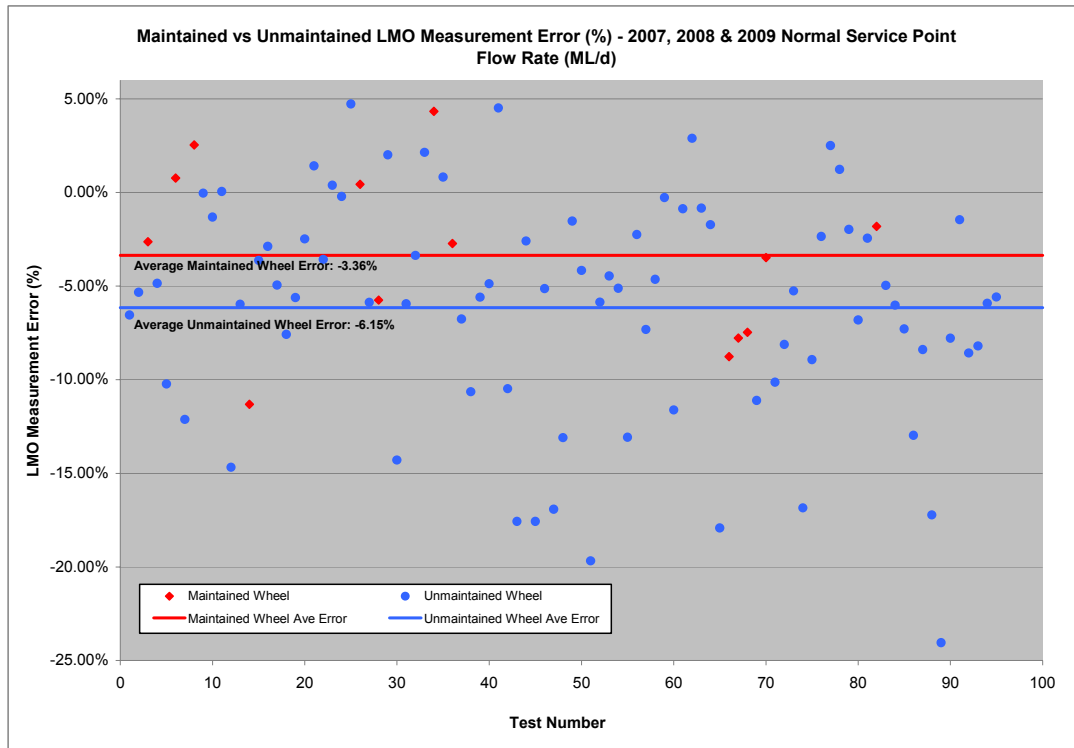
As can be seen in **Figure 12**, the average LMO measurement error for maintained wheels is -3.36% and the average LMO measurement error for unmaintained wheels is -6.15%. Based

on this small sample of meters it can be concluded that on average, maintained LMOs measure more accurately than unmaintained LMOs by approximately 3%.

Figure 12: Maintained vs. Unmaintained LMO measurement error (%).

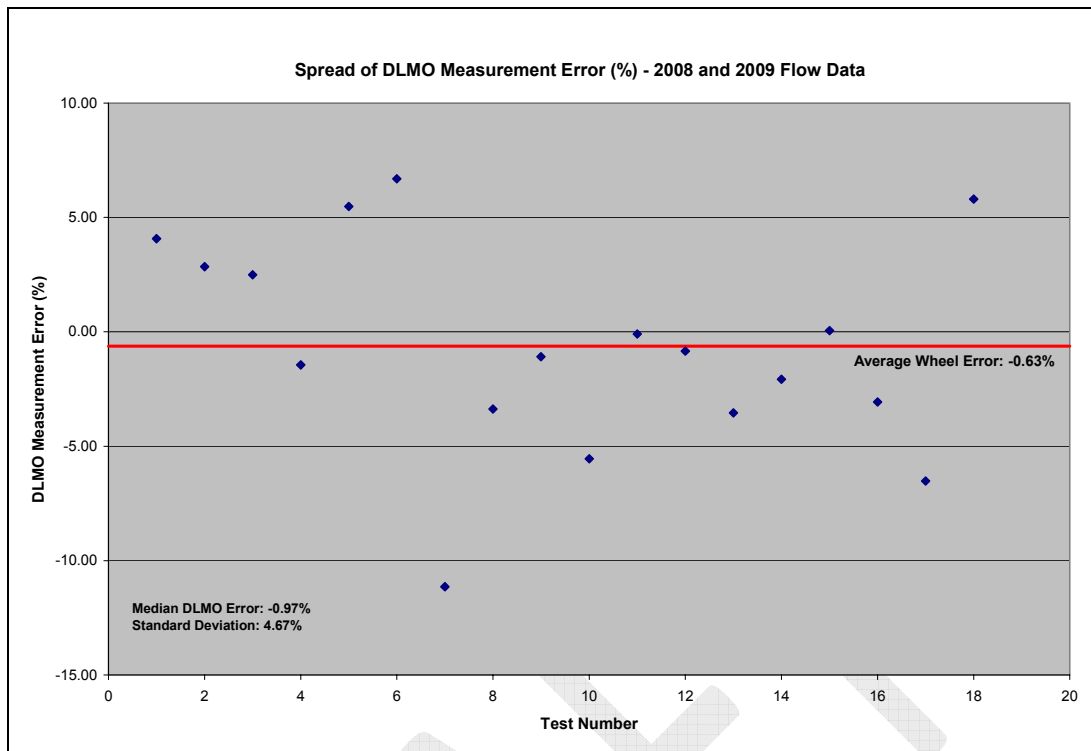
As shown in **Figure 13** the range of DLMO measurement error was between -11.49% and 6.69% with an average of -0.63% and a standard deviation of 4.67%. With such a large standard deviation, the result at 95% confidence limits (two standard deviations away from the mean) is outside of the field specification that an open channel meter must remain within  $\pm 5\%$ , 95% of the time. If required a larger sample of DLMOs should be tested to determine whether the standard deviation of DLMO measurement error is correct.

Figure 13: Spread of DLMO measurement error (%) results.

Based on the results from the analysis of six DLMOs, it can be concluded that on average DLMO measurement within the GMID is significantly more accurate than the LMOs but is still non compliant with the National Standard field specification that an open channel meter must remain within  $\pm 5\%$ , 95% of the time.

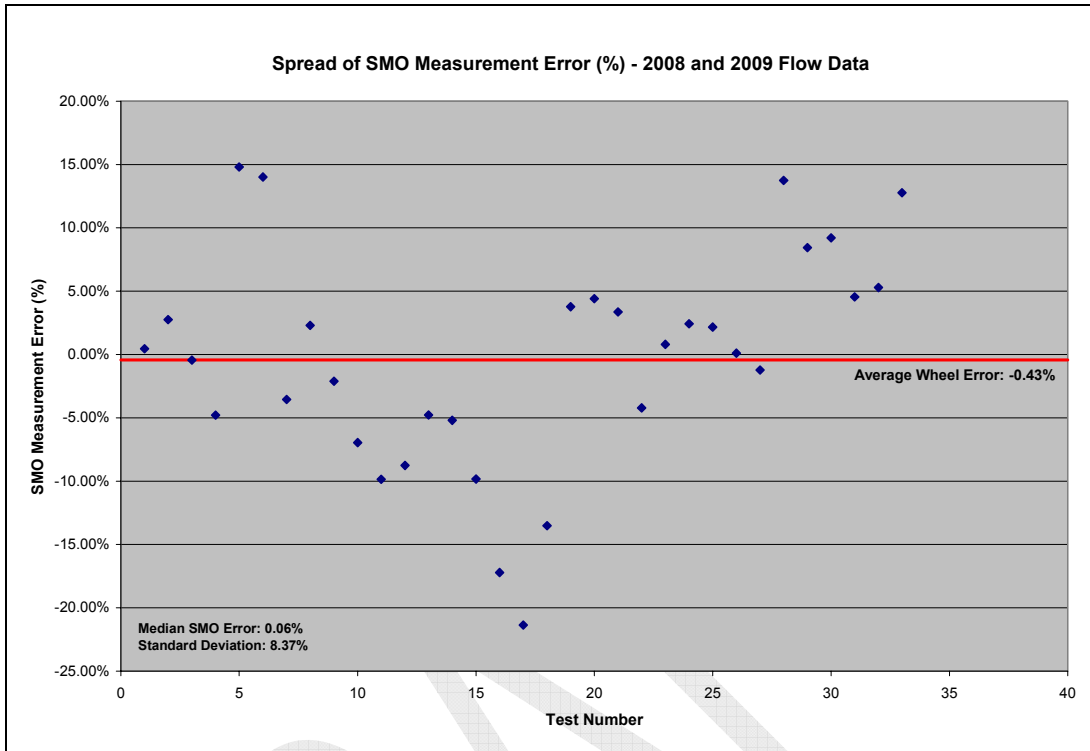
As shown in **Figure 14** the range of SMO accuracy measurements was between -21.37% and 14.81% with an average of -0.43% and a standard deviation of 8.37%. With such a large standard deviation, the result at 68% confidence limits (one standard deviation away from the mean) and 95% confidence limits (two standard deviations away from the mean) is outside of the field specification that an open channel meter must remain within  $\pm 5\%$ , 95% of the time. A larger sample of SMOs should be tested to determine whether the standard deviation of SMO measurement error is correct.

Figure 14: Spread of SMO measurement error (%) results.

Based on the results from the analysis of 11 SMOs, it can be concluded that SMO measurement within the GMID is non compliant with the National Standard field specification that an open channel meter must remain within  $\pm 5\%$ , 95% of the time and that although the average measurement error for those meters tested was better than the LMO a similar spread of error was seen.
