# CG2 Remediation

# CG2 remediation

## Progress report

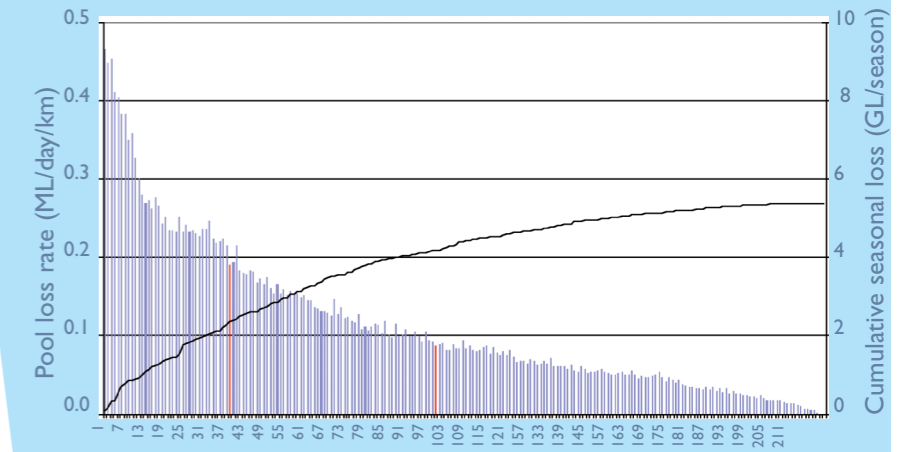
GC1234 pool losses calculated from pondage tests (2006 & 2007) and leak reports

Pool ranking (average of three rankings, not of average rate)

The identification of which pools to target for remediation has been greatly assisted by the use of the TCC technology. At the end of the season the rate of drop in channel pool level can be recorded by the level sensing devices at each regulator. This information is then used to calculate, for each pool, the loss rate and the nature of the loss by the shape of the curve of the level plot. This information can then be used to rank pools by their loss rate. The graph above shows the loss rate of all the pools across the CG1234 system. We have then assessed each pool and determined the best remediation technique to adopt in each case. The highest loss pools have been targeted for the first stage of works this winter.
